Report on the ICOMOS Advisory Mission to Kizhi Pogost (C 544)

1st to 7th July 2014

REPORT ON THE ICOMOS ADVISORY MISSION TO KIZHI POGOST

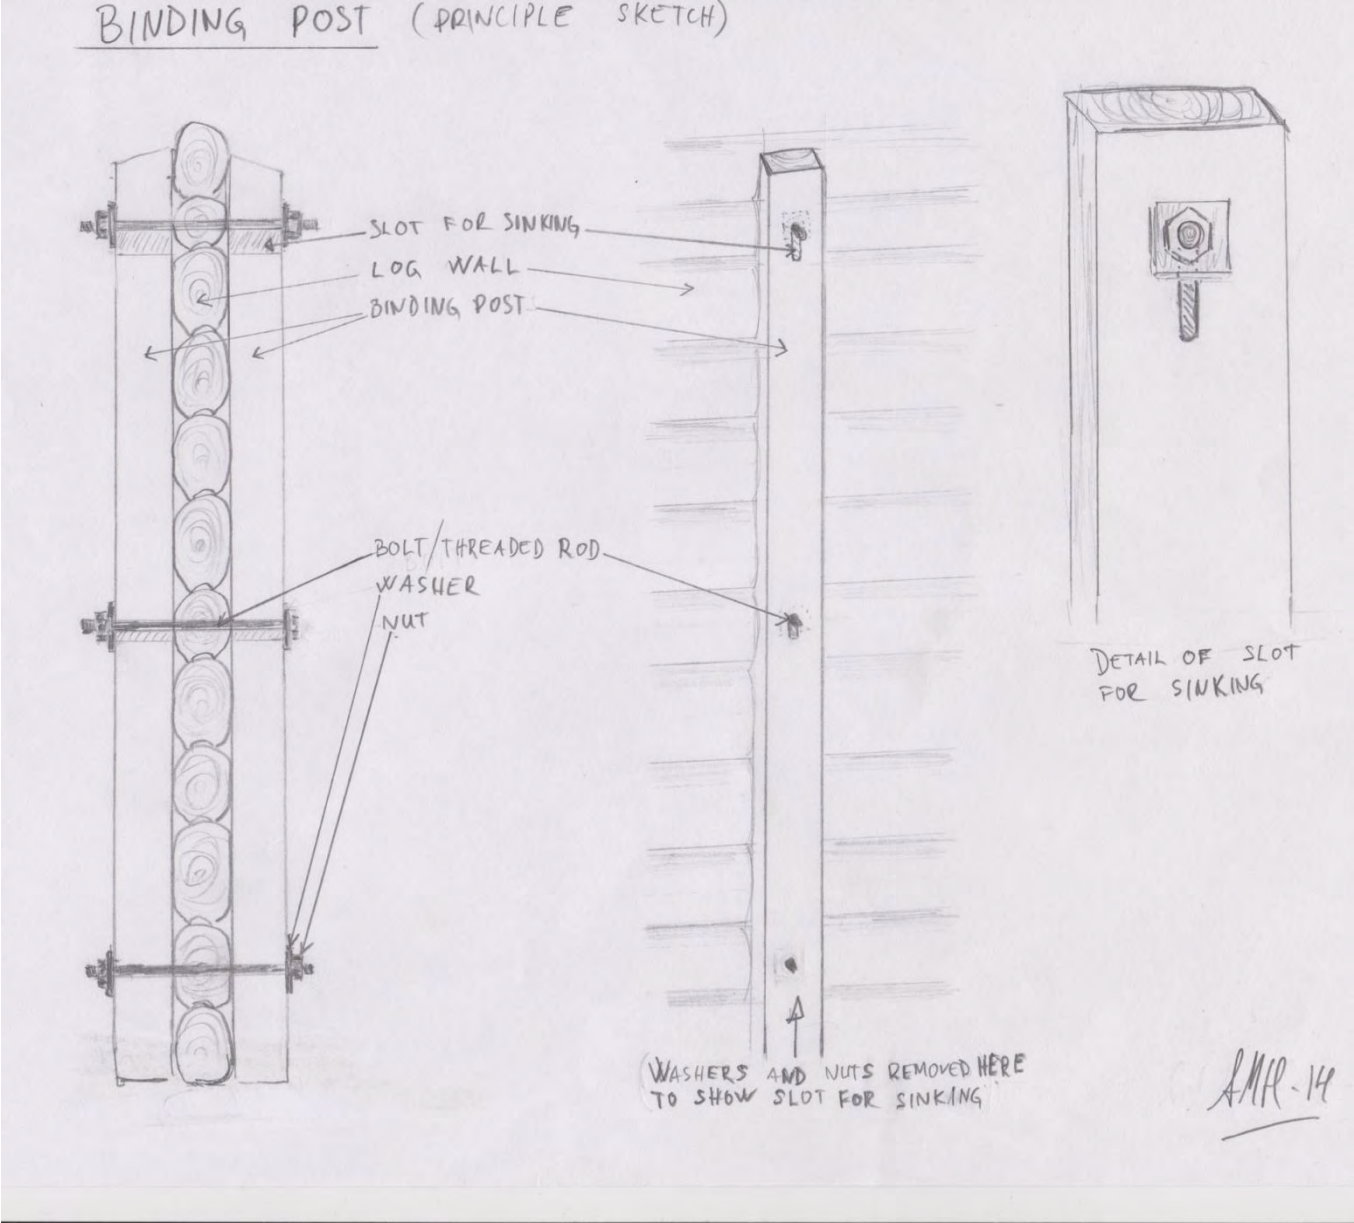
Illustration of Binding Post

At the time of inscription on the World Heritage list, the Church of the Transfiguration already had a support system made of vertical so-called *binding posts* (for an illustration of binding posts, see Annex E). Most likely this system was applied on the church at an early stage, because of the huge dimensions of the building. The mission team has not received certain information on this. Until now the binding posts have been seen as an added support system, and according to recommendations from previous missions, the building should be allowed to support itself without such

Recommendation: The mission recommends that vertical binding posts are reintroduced into the Church of the Transfiguration as soon as possible. It is very important that this is done before any more weight is put on top of the walls. The need to connect some binding posts with horizontal tension rods across the interior of the building should also be considered. Such connections should preferably be done beneath the floor and above the ceiling. It could also be necessary to apply some temporary steel rods in strategic places between the ceiling and the floor during the reassembly of the building, but these should only be used as temporary elements.

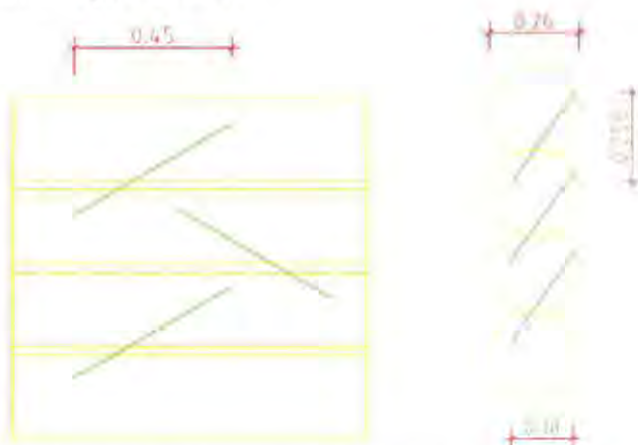
Vernadelung/ Verstärkung mit Schrauben d=8mm in den Wänden

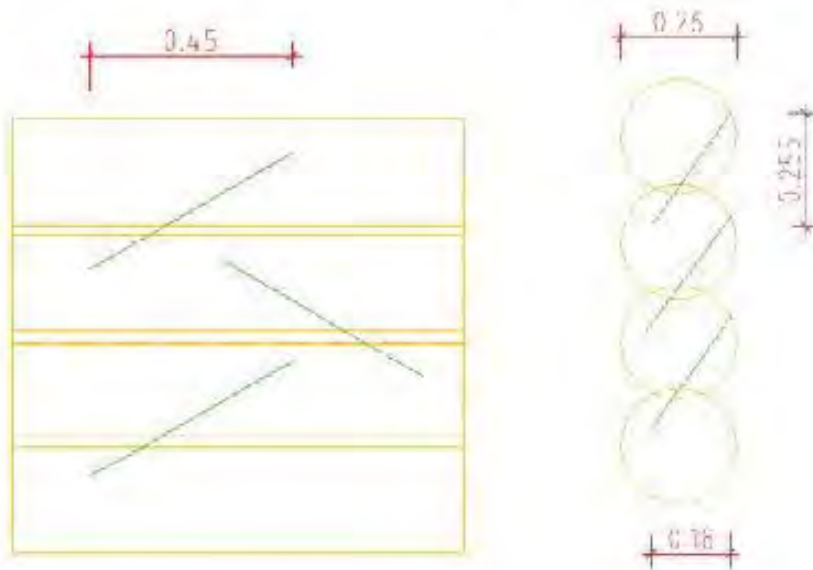
The proposed method requires minimal intervention in historic fabric and preserves the original structural concept compared to alternative methods for reinforcement discussed prior and during this conference. It can be applied locally, thus preventing a fundamental intervention into the existing load-bearing structure, that has, apart from minor restrictions, see item 1-5, been proven satisfactory until 40 years ago.

Fixing/ reinforcement with screws $d=8\text{mm}$ in the walls.

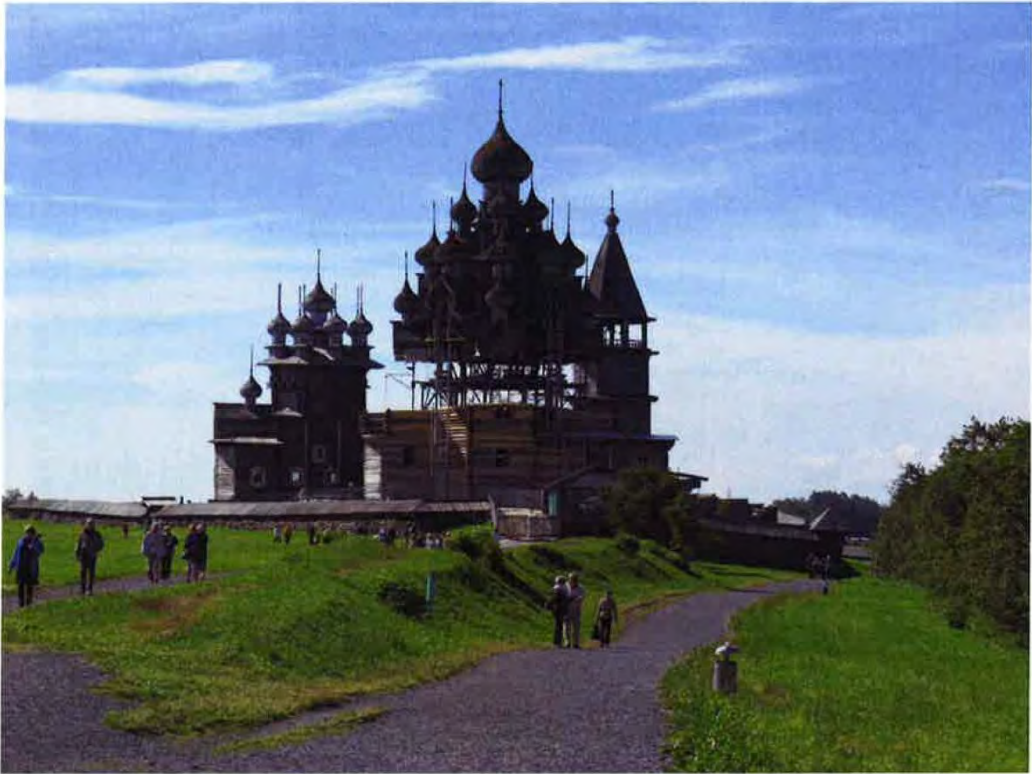
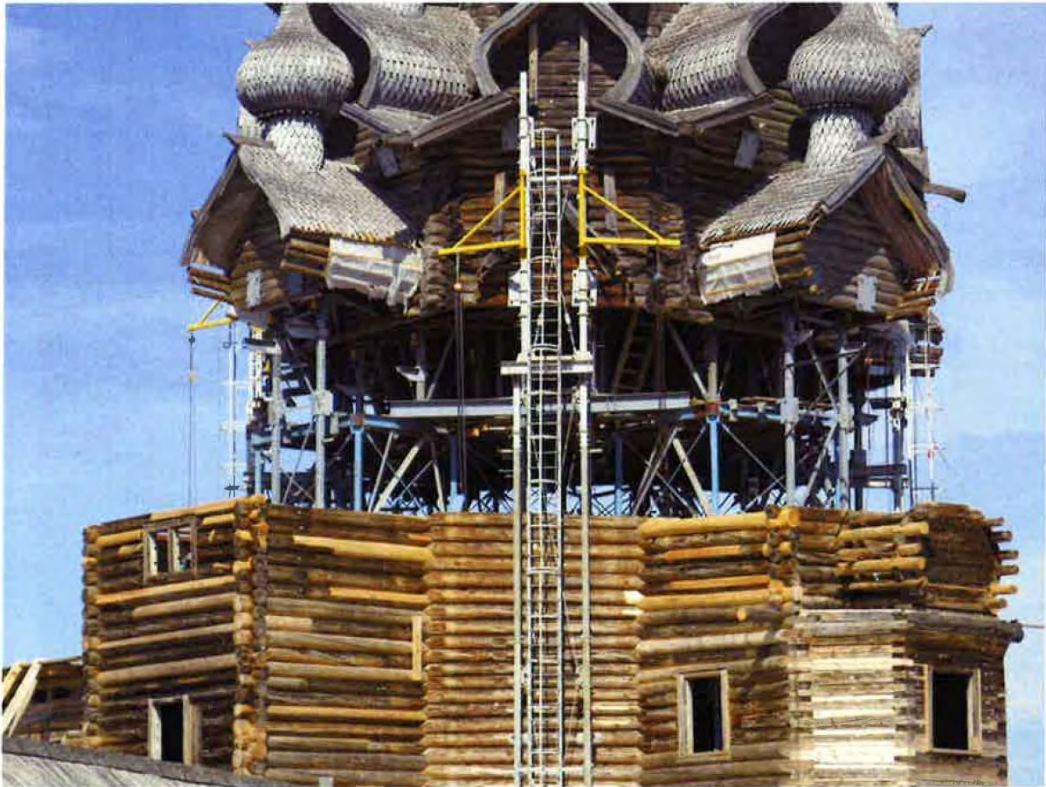
- b. The new pier by the church: The mission noted that there was some building activity at the waterfront by the Kizhi Pogost. According to the museum this is also a temporary project for the celebration of the 300th anniversary of the summer church. The project was described as a reconstruction of the timber pier that was in front of the Pogost before, and this pier was also referred to as a temporary construction that easily can be removed. The mission has no information as to the accuracy of this reconstruction

Building of a new pier by the church pogost.

Recommendation: There should be no distinction made between temporary and permanent structures within the property and its buffer zone. Temporary buildings should be treated the same way as permanent structures. When the Management plan is finalized, new structures should be evaluated in accordance with the regulations of the management plan.

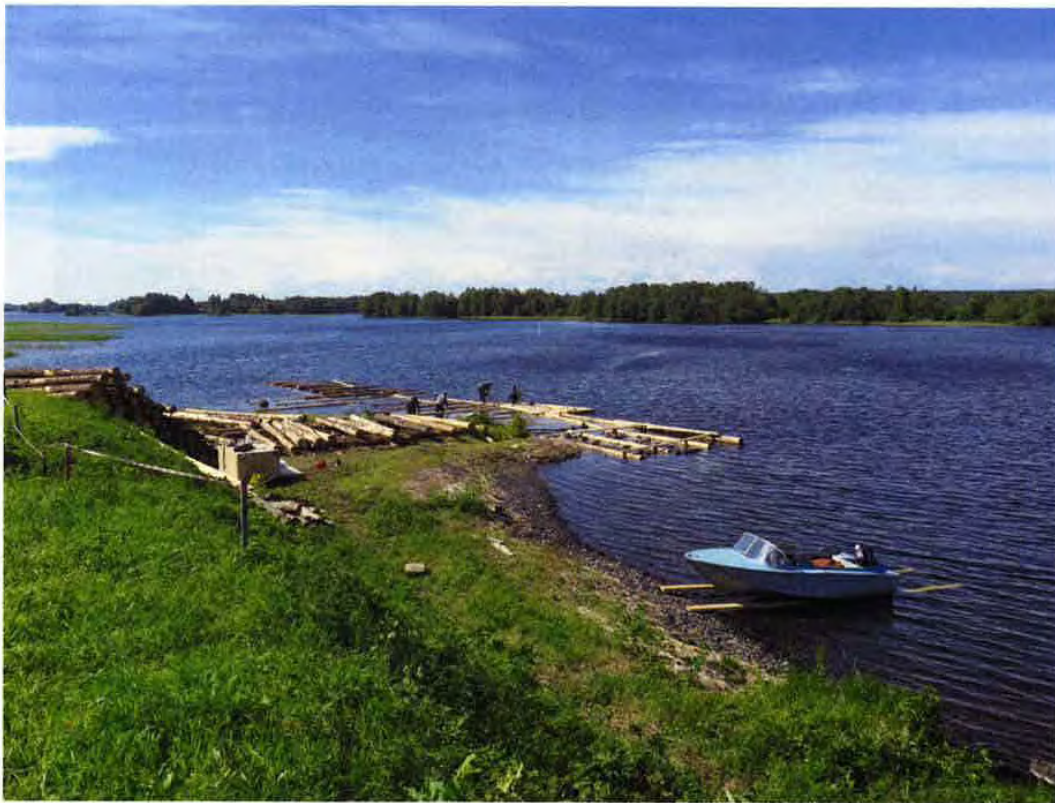
The entrance zone, December 2011.

The mission understands the need for proper facilities at the entrance zone, but reiterates earlier recommendations that no constructions should find place until a Management Plan is adopted and operational. Erection of new constructions at the island, that are not rooted in a comprehensive plan, is very unfortunate, and represents a danger to the OUV of the World Heritage site. Although temporary buildings may be allowed without formal permission from Russian authorities, in conformity with the para.172 and the World Heritage Committee Decisions all projects should be submitted, via Russian national authorities, to the WHC for review by the Advisory Bodies before any irrevocable decision is taken.

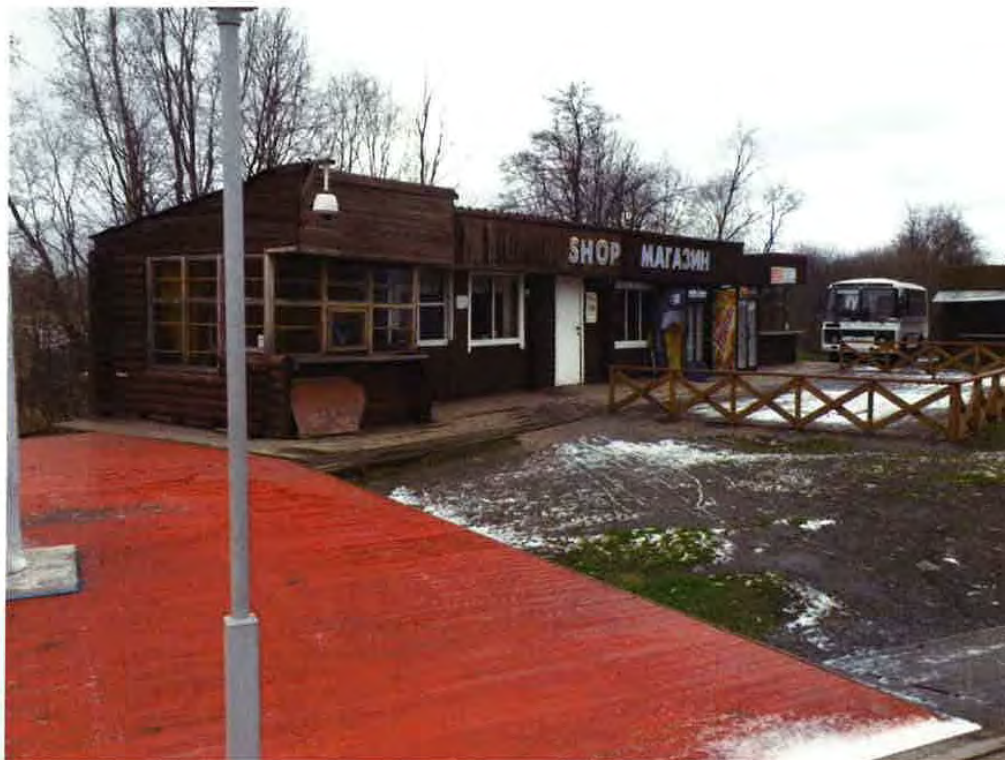
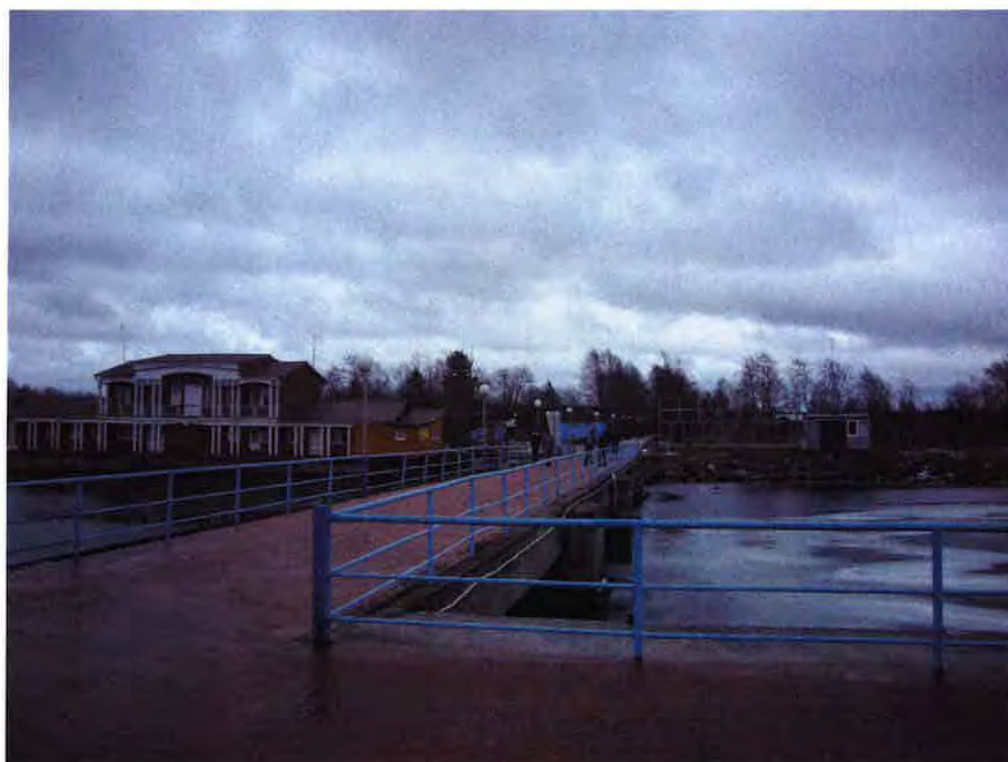
The buildings at the entrance zone have approximately the same shape and location as the previous ones, but the impression of the mission is that the new kiosks appear bigger and increased in number, and the new and large restaurant building has actually replaced an obviously smaller tent. Besides, the mission stresses that temporary buildings might often remain for years, and in fact eventually become permanent. The impact of a temporary structure to the WHS is not different from a permanent structure (See photos, annex Q). Furthermore, no impact assessments were carried out for any of these projects, neither in terms of heritage values nor in terms of environmental protection. As to the way of repairing or upgrading existing buildings, this should all be done with due respect to the heritage, and it should be grounded through precise regulations in the management plan. The mission has done no evaluation on the quality of the new structures, as our biggest concern is about the process. A proper evaluation of the new structures should be done when the Management plan of the area is completed.

The entrance zone, July 2014.

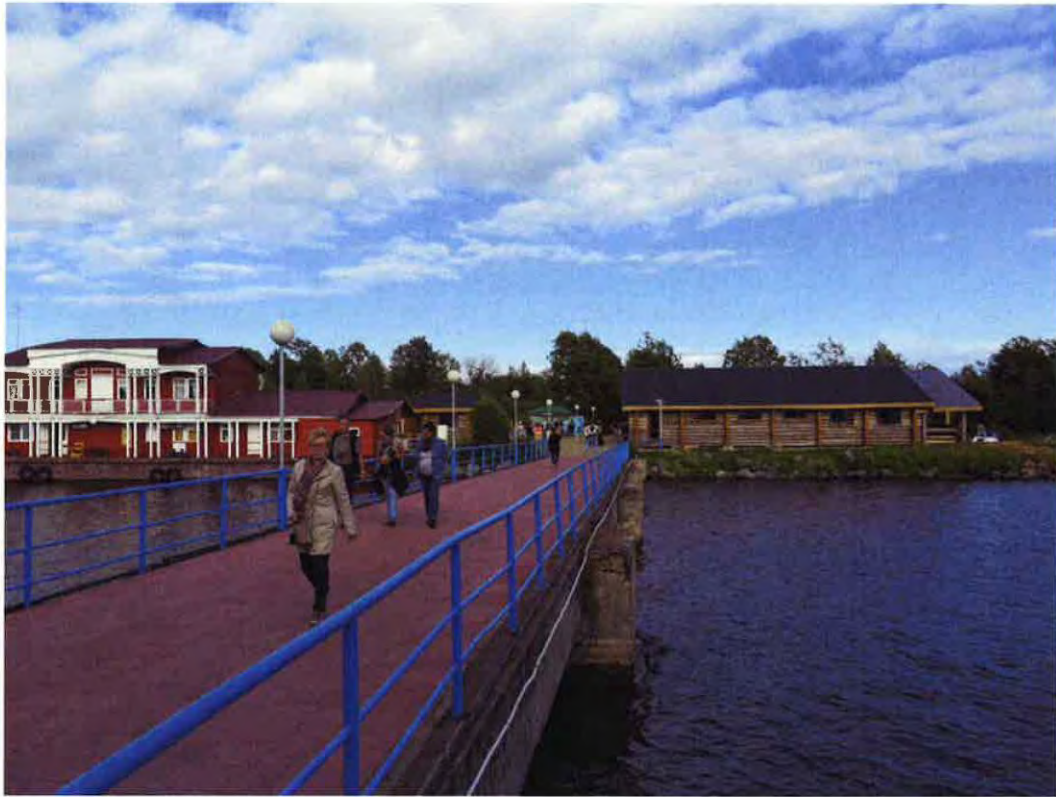
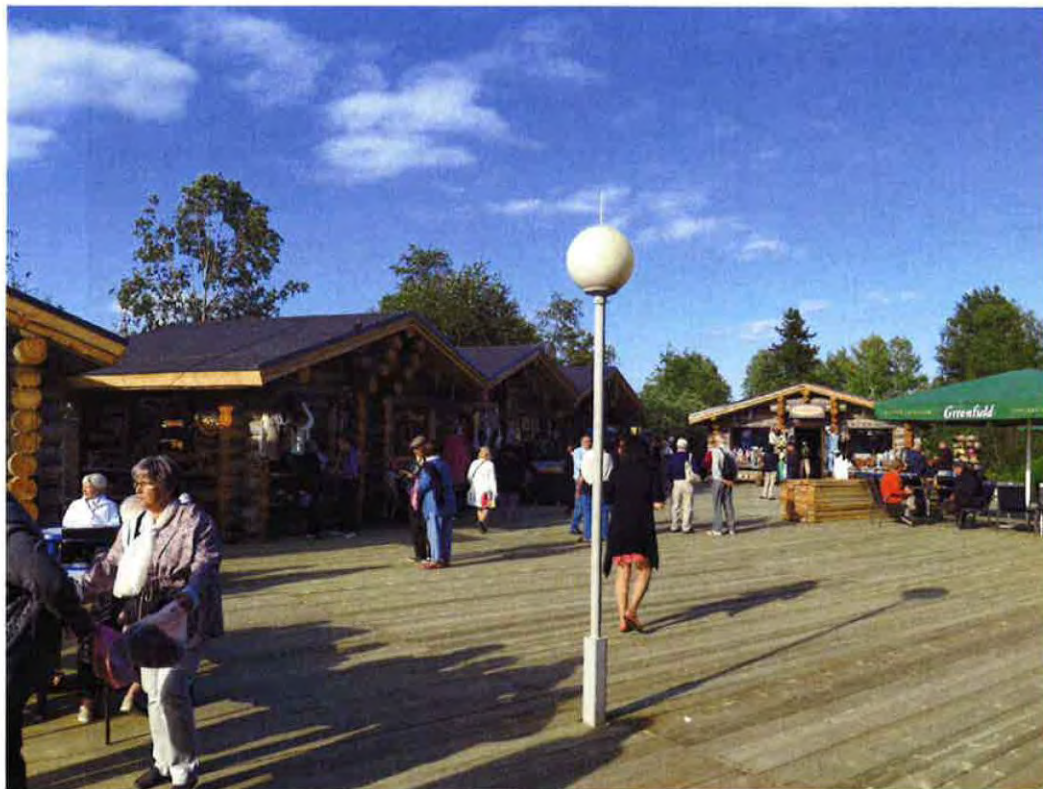
- c. Road from Velikaya Guba to Oyatevschina. The mission was informed that construction is in progress, but has not had the opportunity to view it.
- d. The mission noted that restoration works have been carried out on at least one existing building on the island, a cabin or small dwelling house standing next to the Gogolyevsky guest house. The mission is not familiar with the history of this building, but states that the new exterior makes the building appear as a new house, with cladding and windows significantly differing from the previous ones. The building is not accessible for the public, but it is visible from the sea. The mission is concerned about how the museum, whose aim is to protect the region's heritage, treats its own buildings in a way that does not correspond to conservation principles. The opinion of the mission is that this should not be allowed to make precedence for other house restorations, neither on Kizhi Island, nor in the buffer zone.

Dwelling house by the Gogolevskiy guest house. December 2011.

Recommendation: All restorations projects and other physical measures on buildings should be carried out in accordance with the management plan. All historical buildings should be treated in accordance with conservation principles.

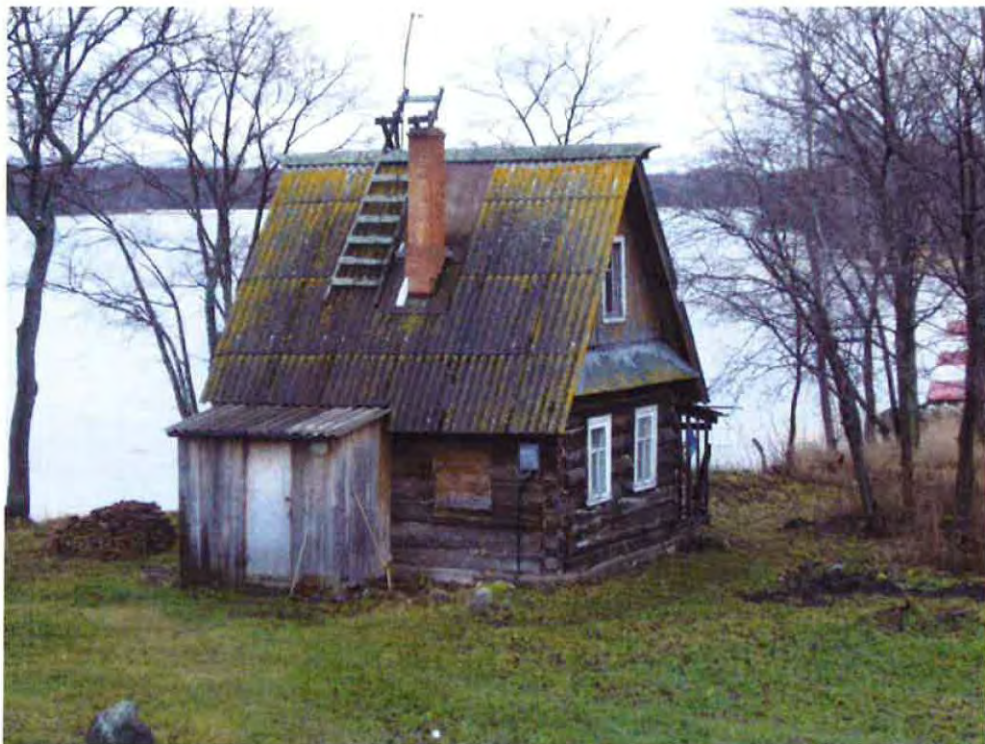
The same house in July 2014.
